*Property Condition Assessments, LLC*

### CHICAGO TRIBUNE PRINTING & DISTRIBUTION FACILITY

***Tribune Real Estate  
Holdings LLC***

**Report Date:**  
November 26, 2018

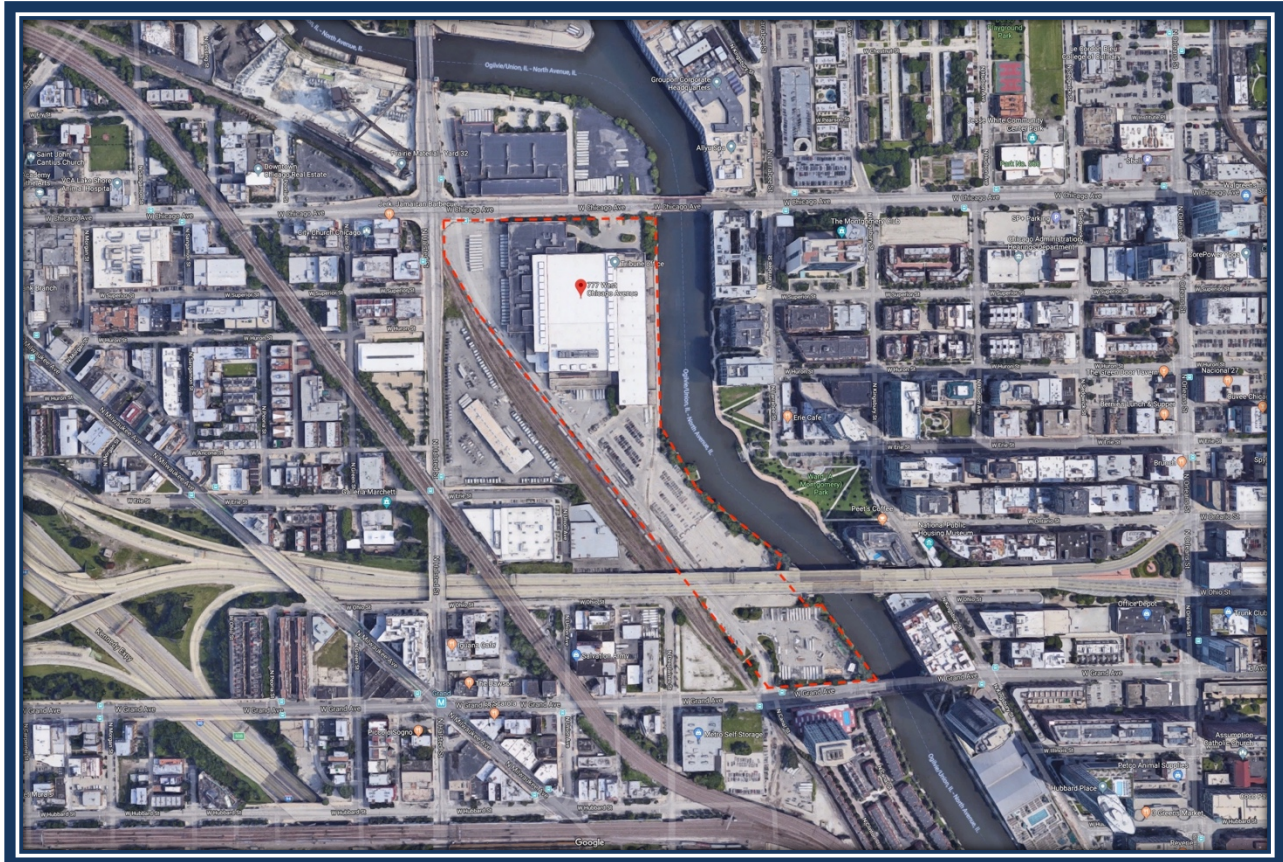
- Description:** The Subject Property is set on multiple land parcels in Chicago, Illinois.
- Site Access:** Vehicular access to the site is provided through two points at the public streets along the site boundary to the north and south. Pedestrian access is accommodated through public sidewalks along those same adjacent streets.
- Site Area:** 24.94 acres, or approximately 2,113,096 square feet.
- Surrounding Area:**
- North:** Freedom Center North (same ownership)
  - South:** High-rise & townhome multifamily residential
  - East:** Chicago River
  - West:** Train tracks, commercial, garage, truck depot (same ownership)
- Shape of Site:** Irregular
